SITE ASSESSMENT

SITE ASSESSMENT  
FOR  
AMERICAN CHEMICAL SERVICE  
GRIFFITH, INDIANA

Prepared For:  
U.S. Environmental Protection Agency  
Region V  
230 S. Dearborn Street  
Chicago, Illinois

December 1984

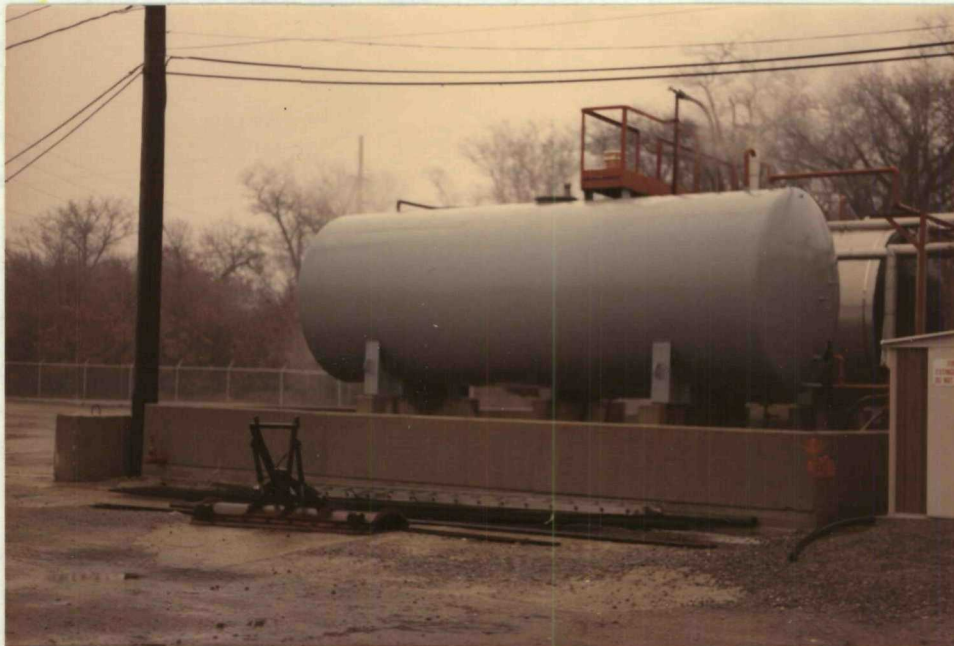
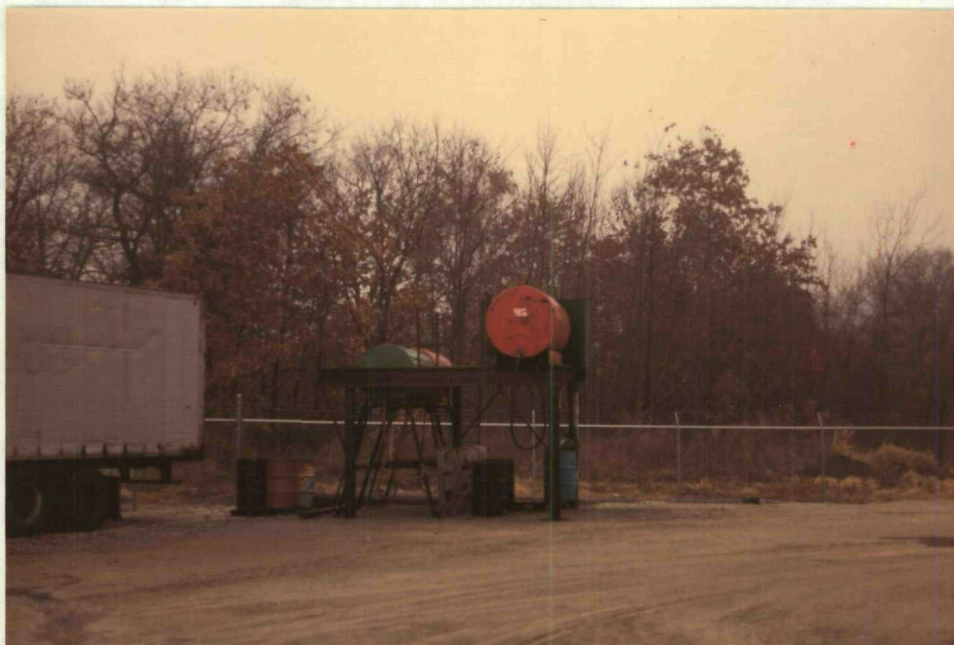
- Have daily tank logs
- Has emergency coordinator (see plan)
- # 2 fuel oil tanks have cement diking with a water drain valve that is closed when not in use, it is also checked daily
- All tank farms have earthen diking of adequate size

Subject: #2 Fuel oil tanks with dike and water drain valve	Facility: American Chemical Services
Photographer: Sally Matz	Witnesses: Curtis R. Michols
Date/Time Direction: 12-12-84/1345/N.E.	Camera/film/attachments: Olympus 35mm/100ASA
Subject: Storage tanks for vehicular use	Facility: American Chemical Services
Photographer: Sally Matz	Witnesses: Curtis R. Michols
Date/time/direction: 12-12-84/1400/N	Camera/film/attachments: Olympus 35mm/100ASA

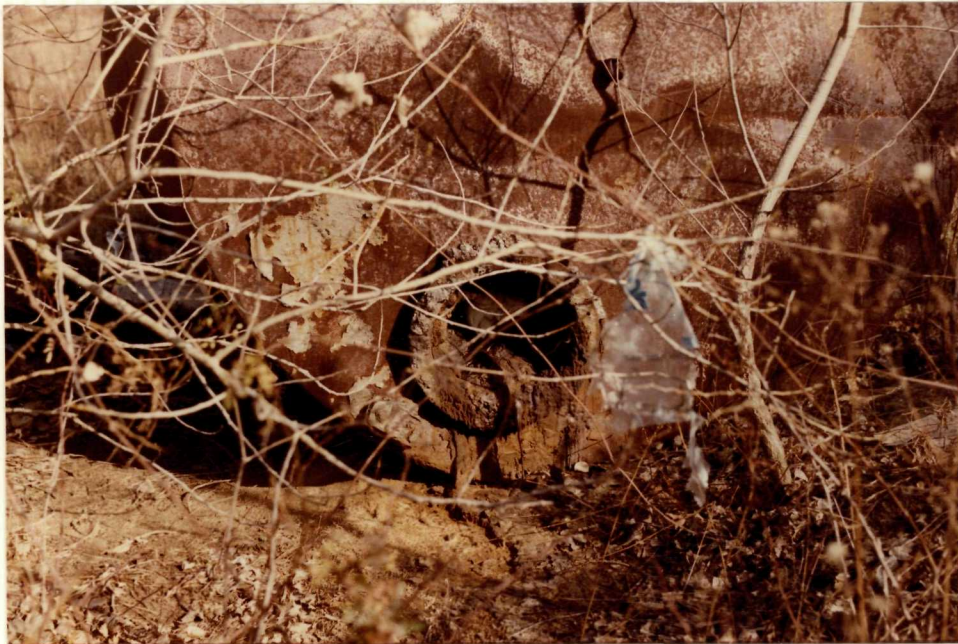
PHOTO 1  
Fuel tank at east  
side of drum fill.

With the possible exception of the abandoned fuel tank on the landfill, no other conditions were observed which could pose an imminent threat to the public safety via direct contact of wastes. The physical description of material in the tank does not tend to support ACS's contention that this is simply an old fuel oil tank; as such, ACS should be encouraged to

relocate the tank in a secure area until a definitive description and, if necessary, final disposition of the materials contained in the tank can be achieved.

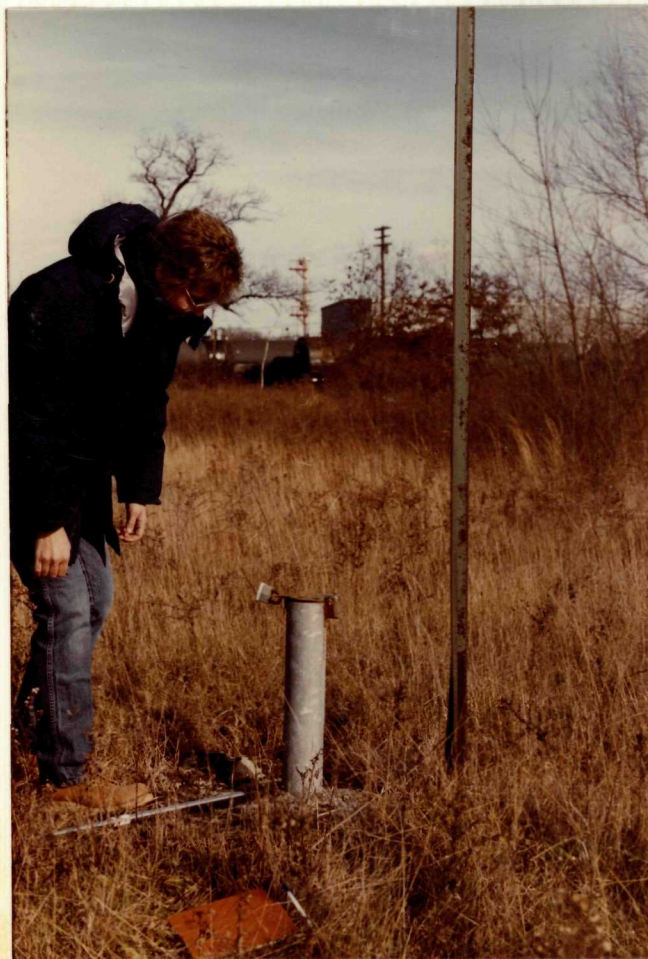
PHOTO 2  
Monitor well #1

Messrs. Tarpo and Murphy then toured the ACS fill and nearby area with the TAT, pointing out the location of the monitoring wells. Later, the TAT attempted to open the casing locks on these wells to obtain HNU readings. None of the locks on the wells could be opened, and the casing caps appeared to be rusted shut. The TAT then examined the E&L rail bed along the southwestern edge of the Griffith landfill. No leaching problems were encountered. A similar investigation was made along the C&O rail line north of the landfills. A drainage ditch along the rail line was found to contain clear water; no abnormal HNU readings were obtained, nor was evidence of leaching found. Another drainage ditch, running roughly parallel to the aforementioned ditch, was observed. It appeared to originate in the area between the ACS fill and the current Griffith operations and was interrupted at one point by soil which had apparently been bulldozed into it. At this point, the water was very dark, odorous, and gas was noted emerging from the sediments. Both ditches were eventually intercepted by another ditch running perpendicular to the C&O tracks, northwest of the Griffith landfill. This ditch connects, by means of a culvert, the mar-

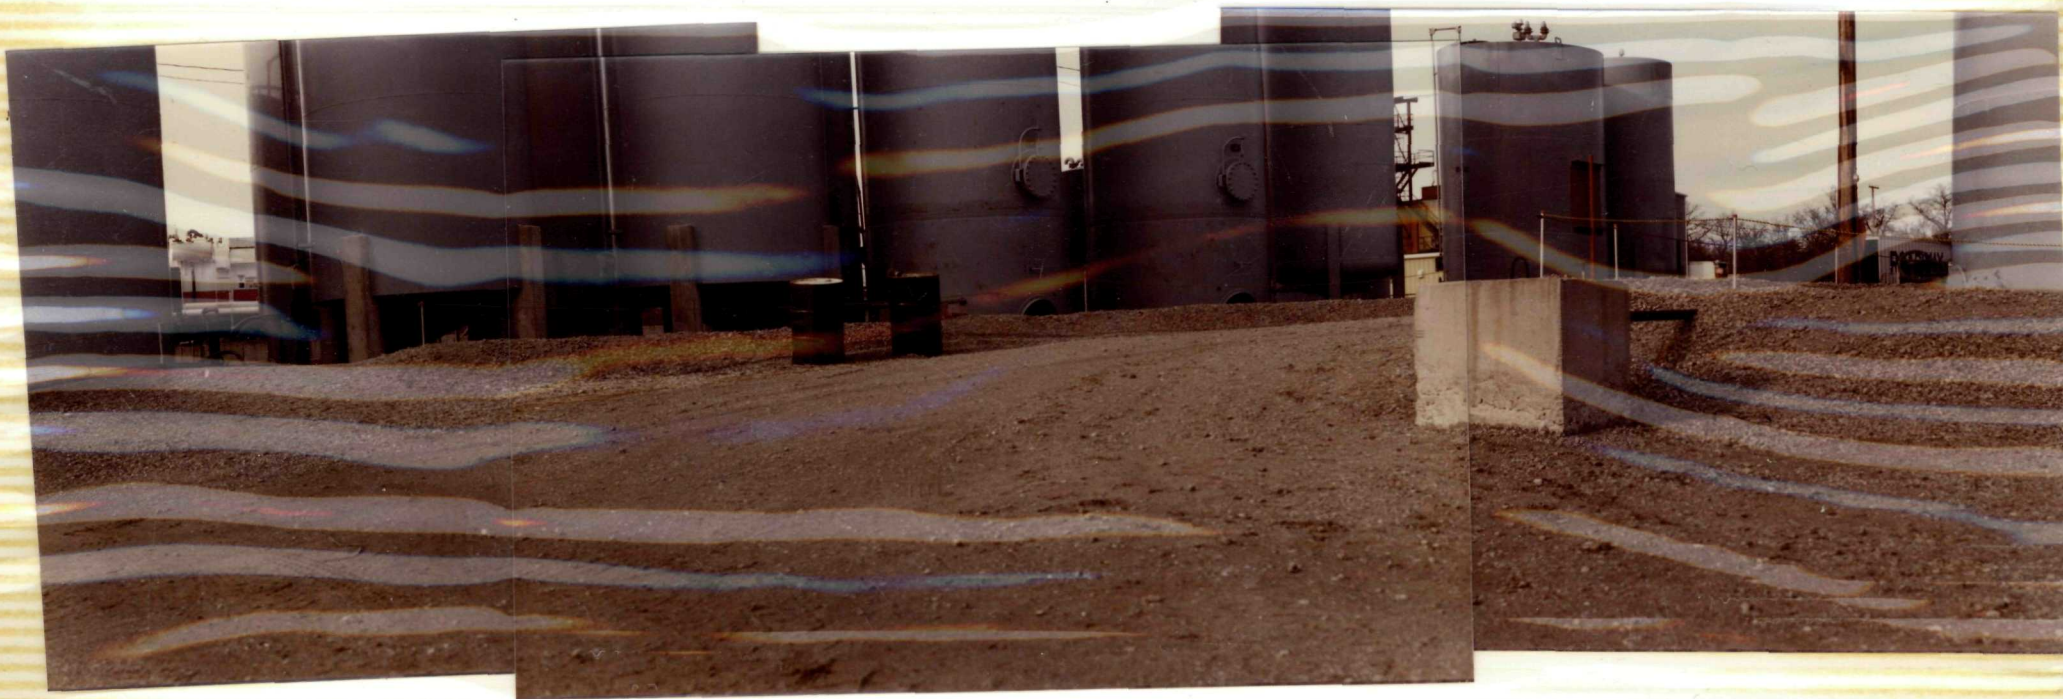
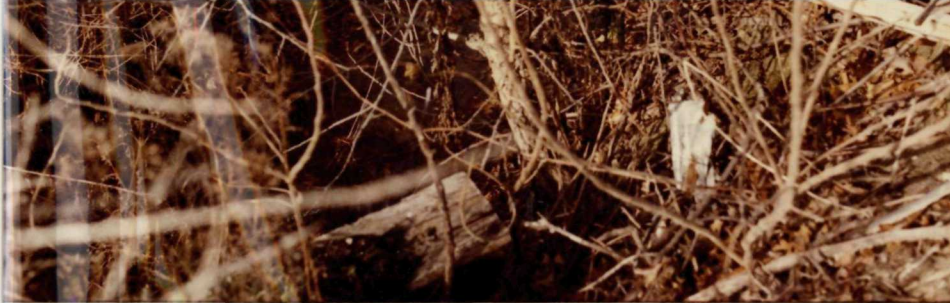
PHOTO 4, 5 & 6  
Area of old lagoon  
on American Chemical  
Services site

Upon completion of the interview, Messrs. Tarpo and Murphy showed the TAT an area on site which they stated was the location of the covered waste lagoon. The former lagoon was located to the northwest of the process building, at the west end of the site. A slight rise in the land was observed at this location. A tank battery was noted to occupy much of the area that was formerly the lagoon. The fire pond, located due west of the lagoon area, was then inspected. Mr. Tarpo indicated that the water level in the pond was maintained by overflow diversion into the sewer system. Mr. Tarpo also stated that no waste filling west of their pond had occurred.

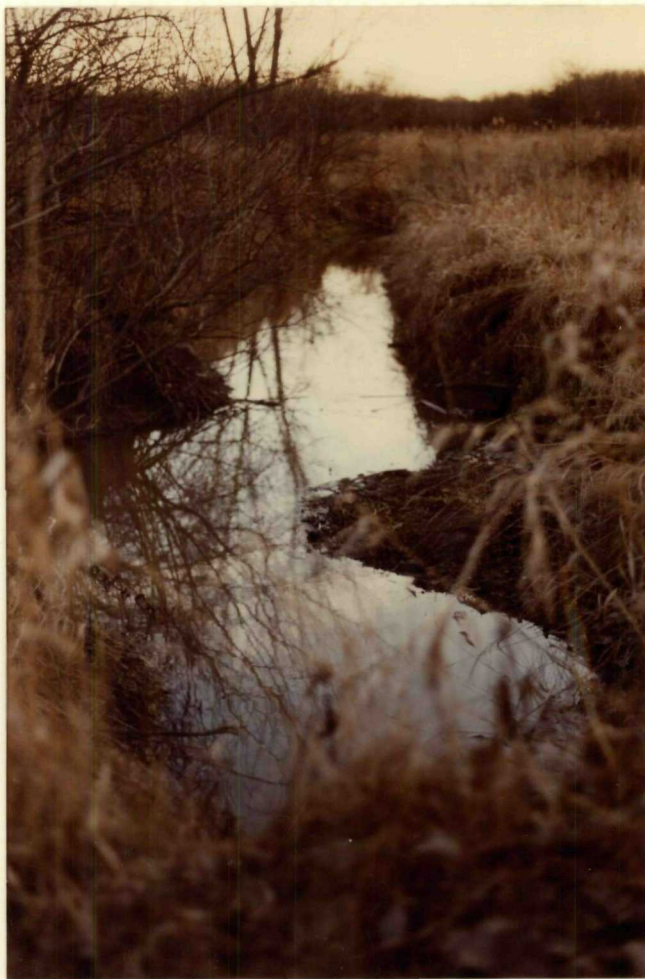
PHOTO 15  
Confluence of  
drainage ditches  
NW of monitor well  
#3

shes located north and south of the C&O tracks. At the confluence of the ditches, the water from the "on-site ditch" was noted to be clear with no discoloration or odor present.
